## Dam Inspection Report

Name of Dam Wonder Lake Dam ID No. IL00585

Type of Dam: Earth-Fill Embankment with Ambursen Spillway

Date(s) Inspected 10/14/2022

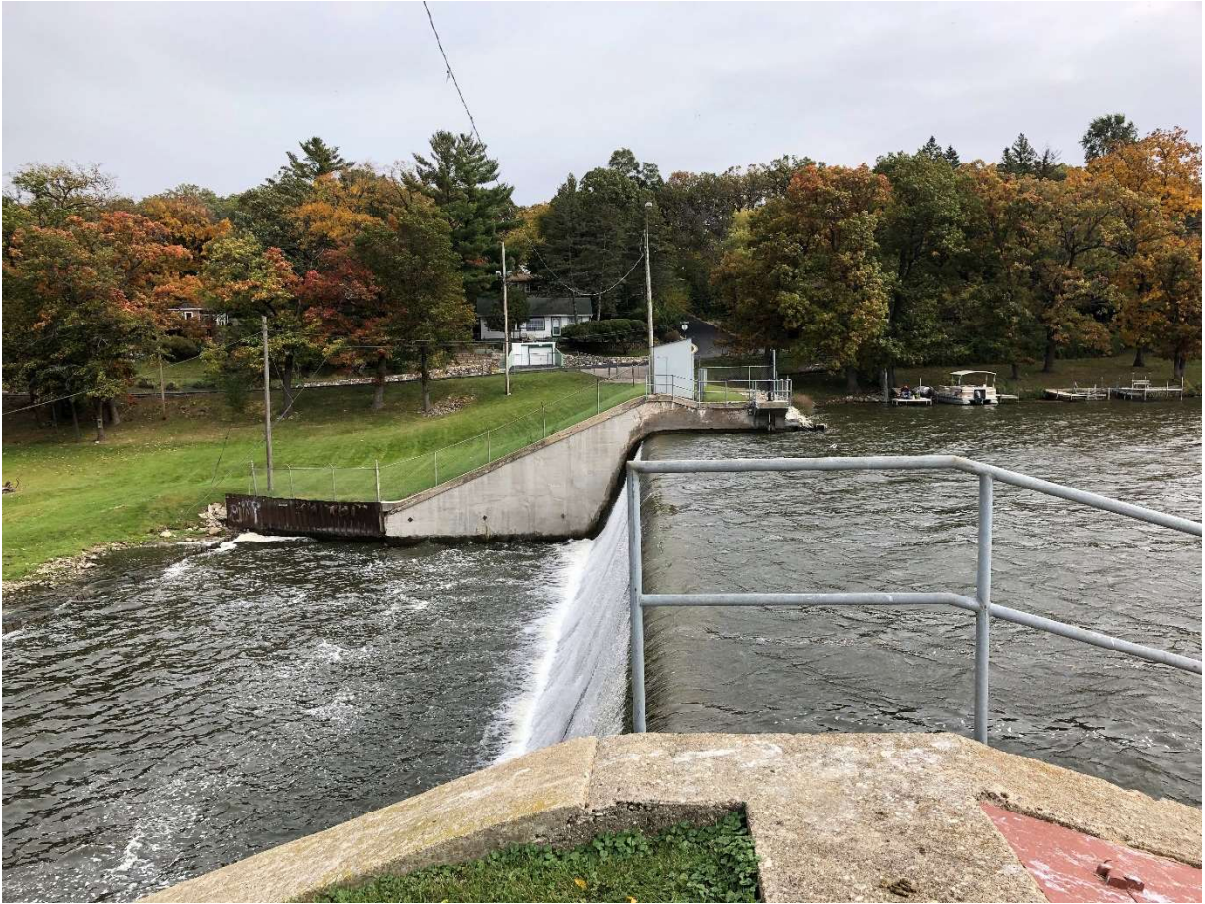
Photo 1: Spillway Crest (Facing east)

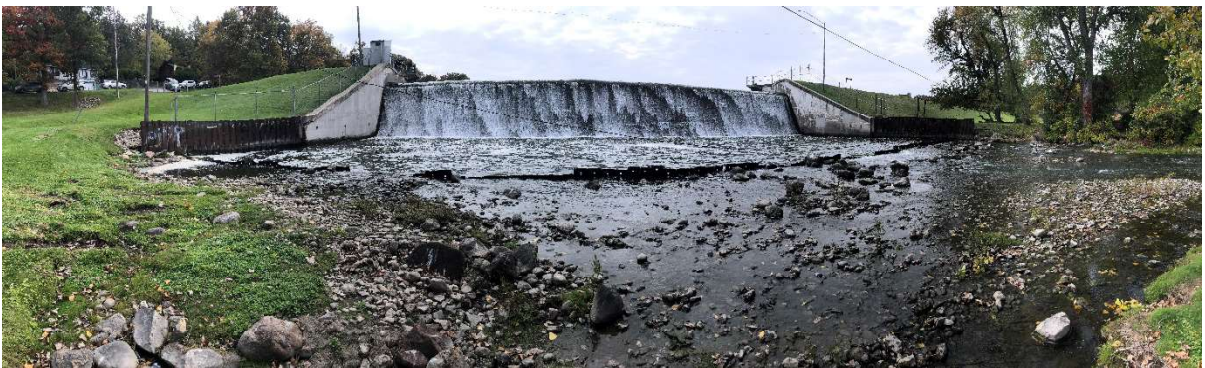
Photo 2: Downstream Face of Spillway

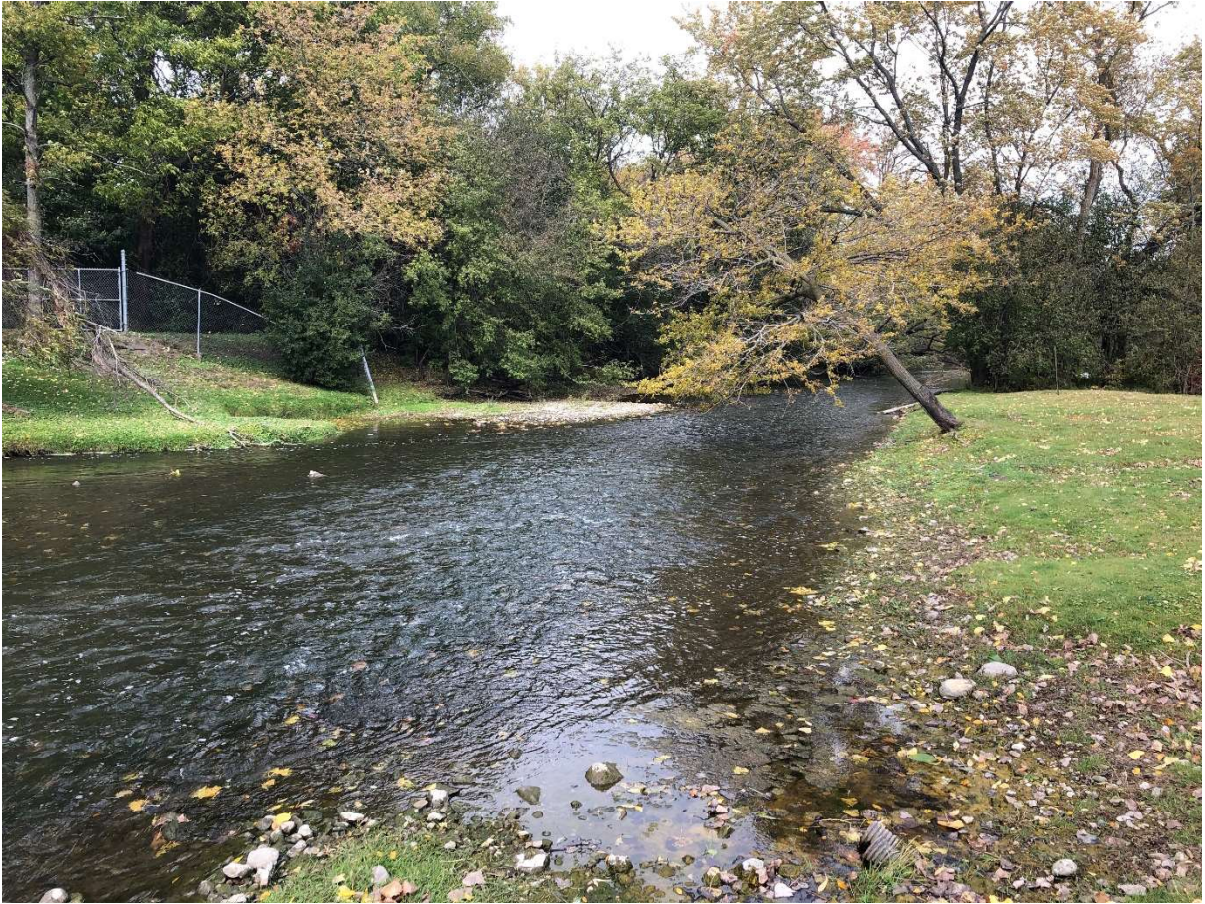
| ITEM | CONDITION<br>CODE | DEFICIENCIES | RECOMMENDED REMEDIAL MEASURES<br>AND IMPLEMENTATION SCHEDULE |
|---|---|---|---|
| Outlet Channel | GC | Minor erosion but overall good<br>condition and stable.<br>No threat to dam. | |

Photo 3: Downstream Channel

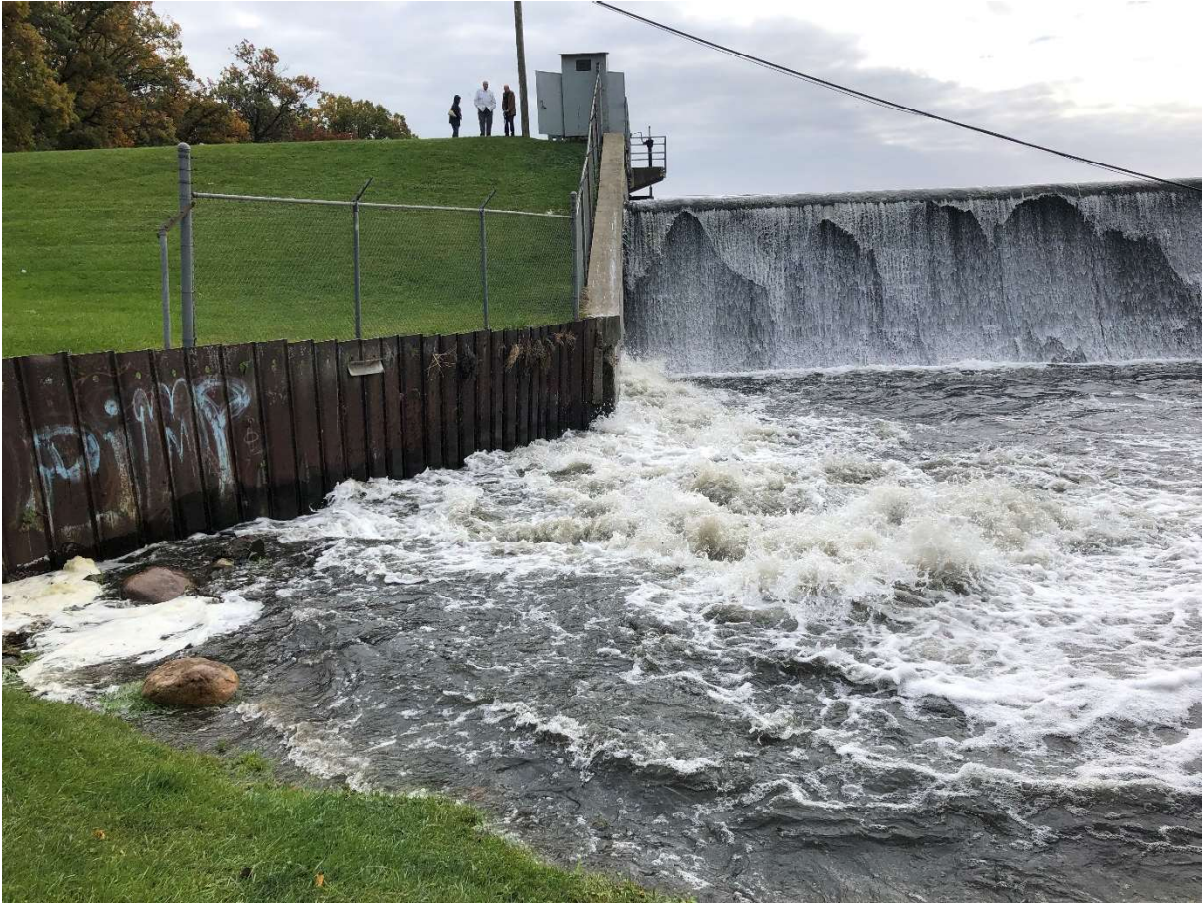
| ITEM | CONDITION CODE | DEFICIENCIES | RECOMMENDED REMEDIAL MEASURES AND IMPLEMENTATION SCHEDULE |
|---|---|---|---|
| Gate Sill | GC/MM | East Gate was opened and closed during the dam inspection. There are no issues with the gate components. West Gate inoperable. | Repair West Gate. |

Photo 4 - Downstream Face of Spillway with Sluice Gate Open (East Abutment)

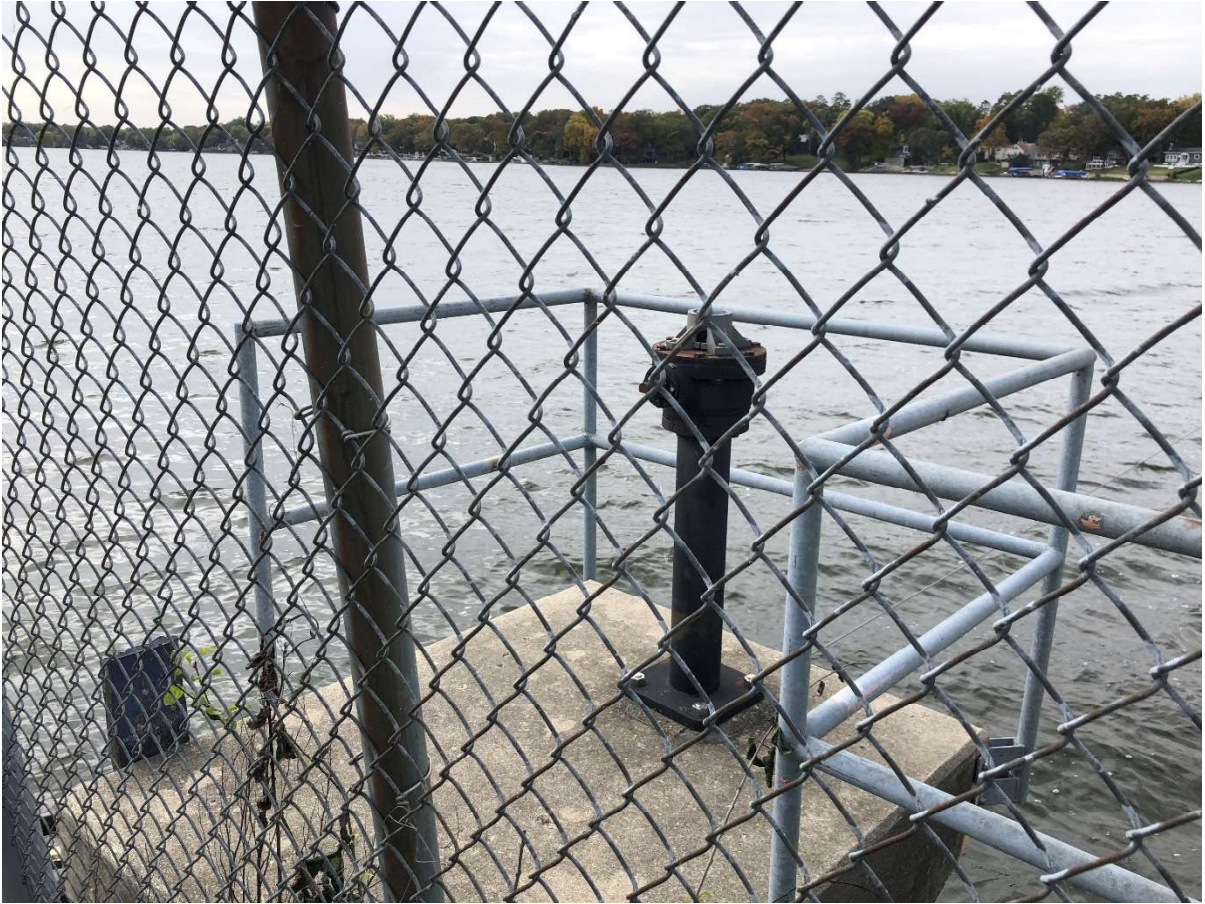
Photo 8: East Sluice Gate Control

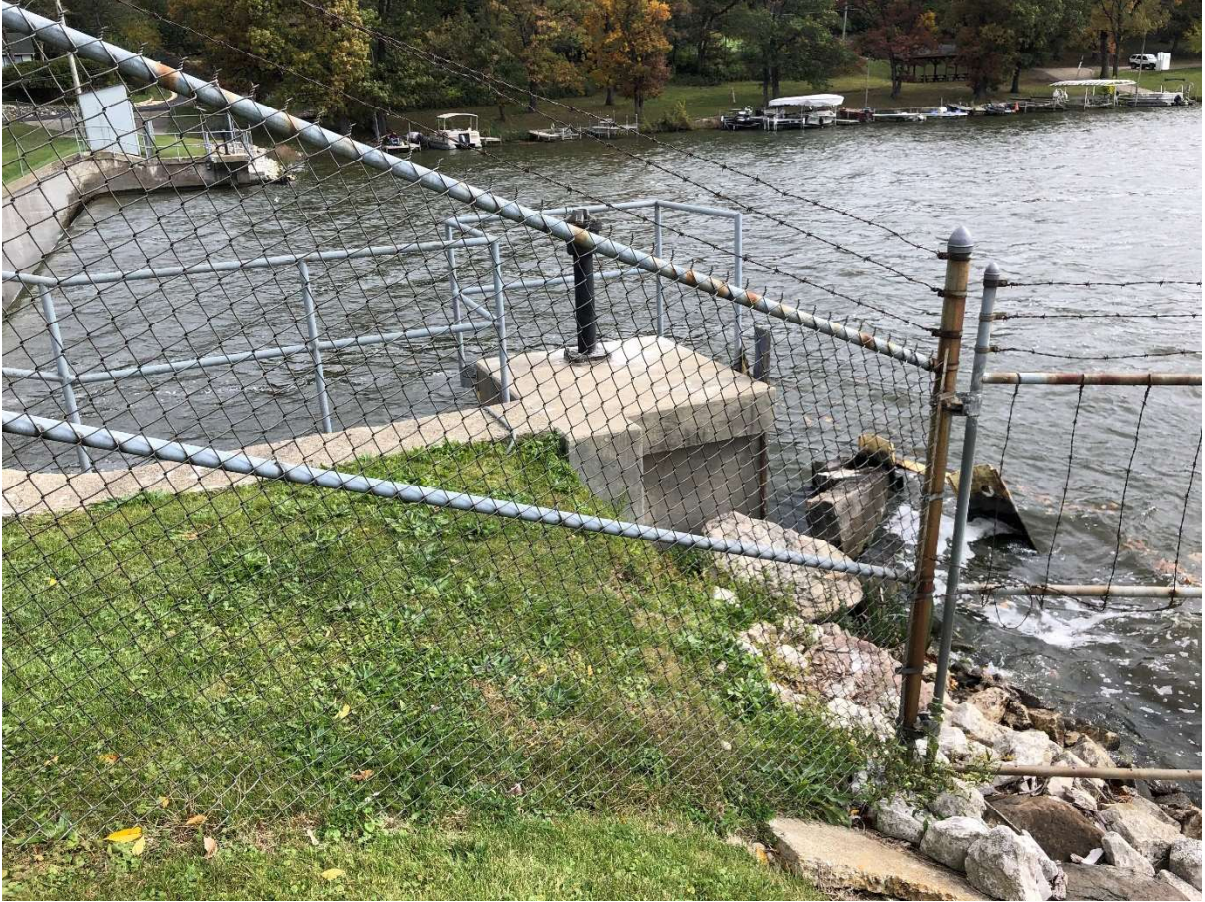
Photo 9: West Sluice Gate Control

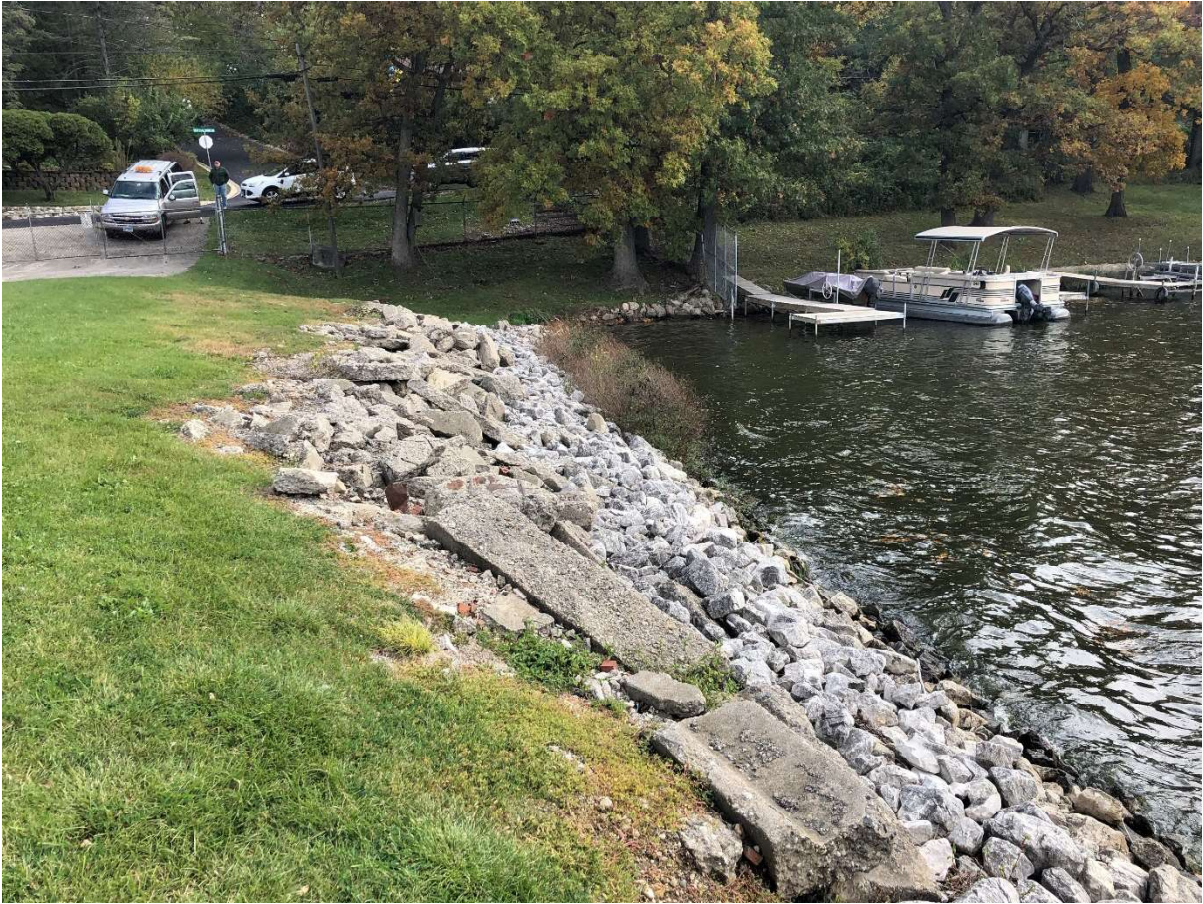
| ITEM | CONDITION<br>CODE | DEFICIENCIES | RECOMMENDED REMEDIAL MEASURES<br>AND IMPLEMENTATION SCHEDULE |
|---|---|---|---|
| Upstream Face<br>Slope Protection | GC | | RipRap is in good shape |

Photo 11: East Embankment – Upstream Face Riprap (Facing East)

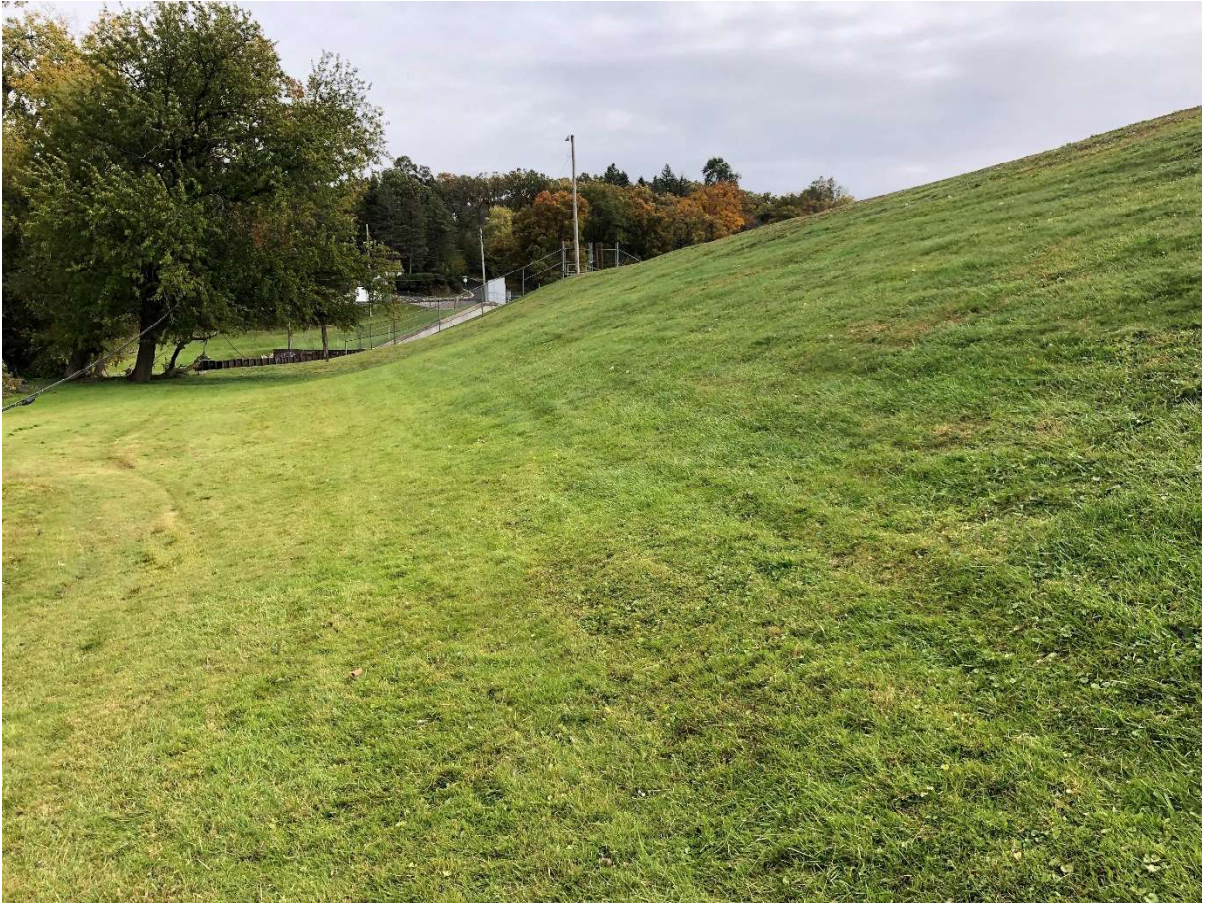
| ITEM | CONDITION<br>CODE | DEFICIENCIES | RECOMMENDED REMEDIAL MEASURES<br>AND IMPLEMENTATION SCHEDULE |
|---|---|---|---|
| Seepage | OB | <i>There is some standing water at<br/>toe of west embankment due to<br/>adjacent Fen located to the north</i> | <i>Monitor for any changes<br/>This wet area has remained unchanged from the<br/>October 13, 2016 Dam Inspection</i> |

Photo 12: Downstream Side of West Embankment (Facing East)

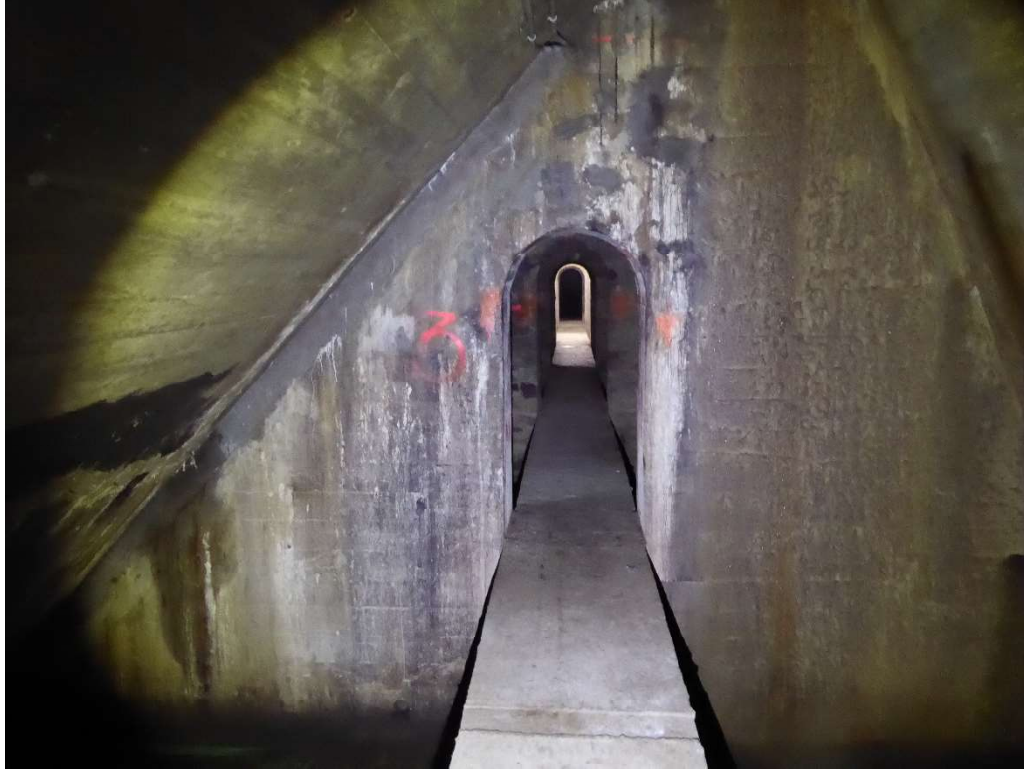
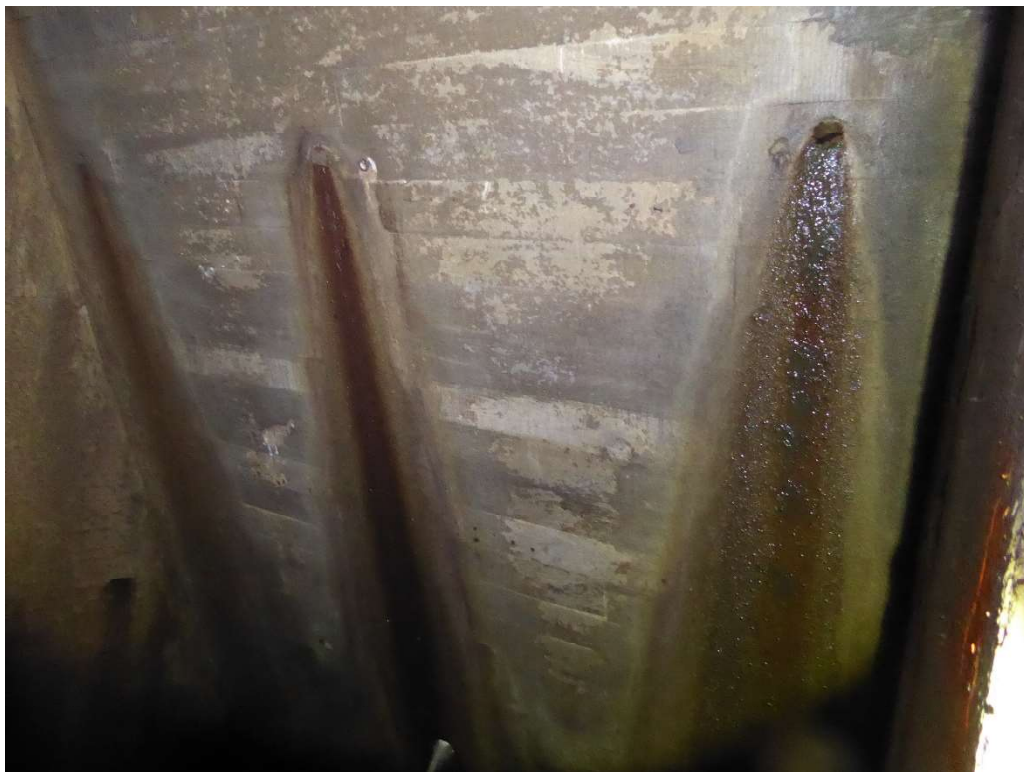
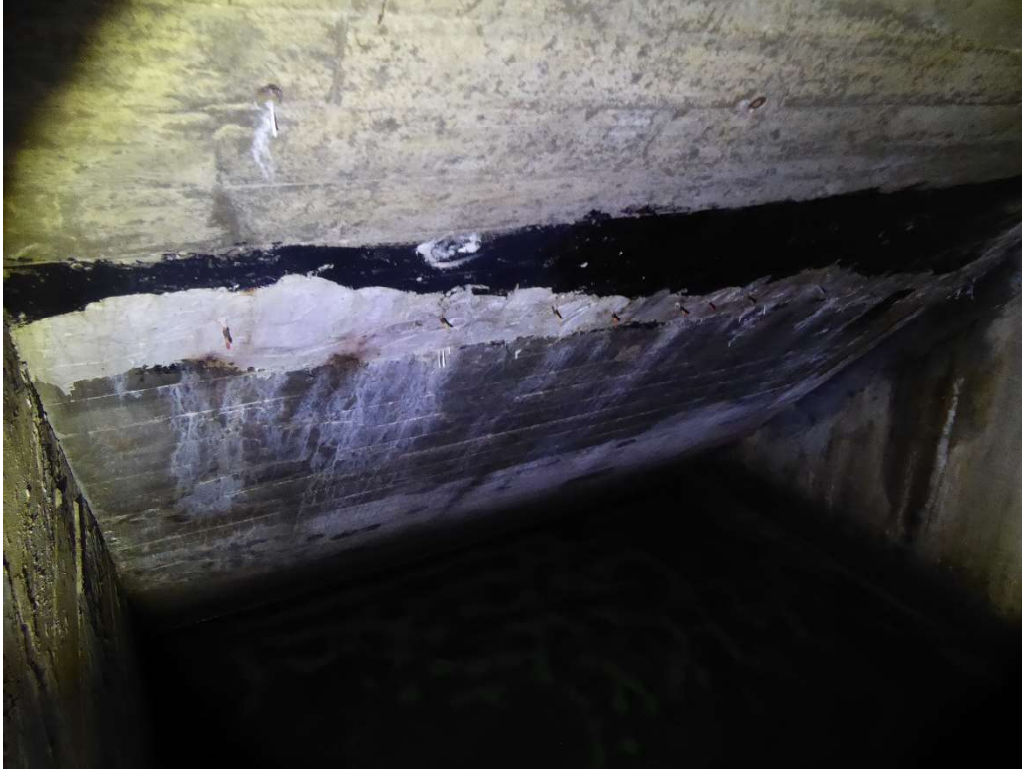
| Drop Inlet Spillway | | Overflow Spillway Structure (Ambursen) | | Gated |
|---|---|---|---|---|
| Seepage Around or Into Structure | MM | Minor seepage and weeping thru several walls. There were seepage through top of spillway at chamber 7. The seepage at chamber 7 is less than year's inspection. | Continue to monitor. MOPA indicated that they had some repair done since last inspection. The leakage at chambers 3 & 7 is considerably reduced since last year's inspection. Keep monitoring. | |
| Structural Cracks | MM | There are some minor cracks at within most chambers. Cracks within chamber 3 & 7 have been patched since last inspection. | Continue to monitor for any changes to current conditions. Area around cracks have been repaired. | |

Photo 27: Chamber #3

Photo 28: Downstream Face - Chamber #3

Photo 29: Upstream Face – Chamber #3

*Repairs have been completed in  
Chambers #3 & 7 that have reduced  
seepage.*

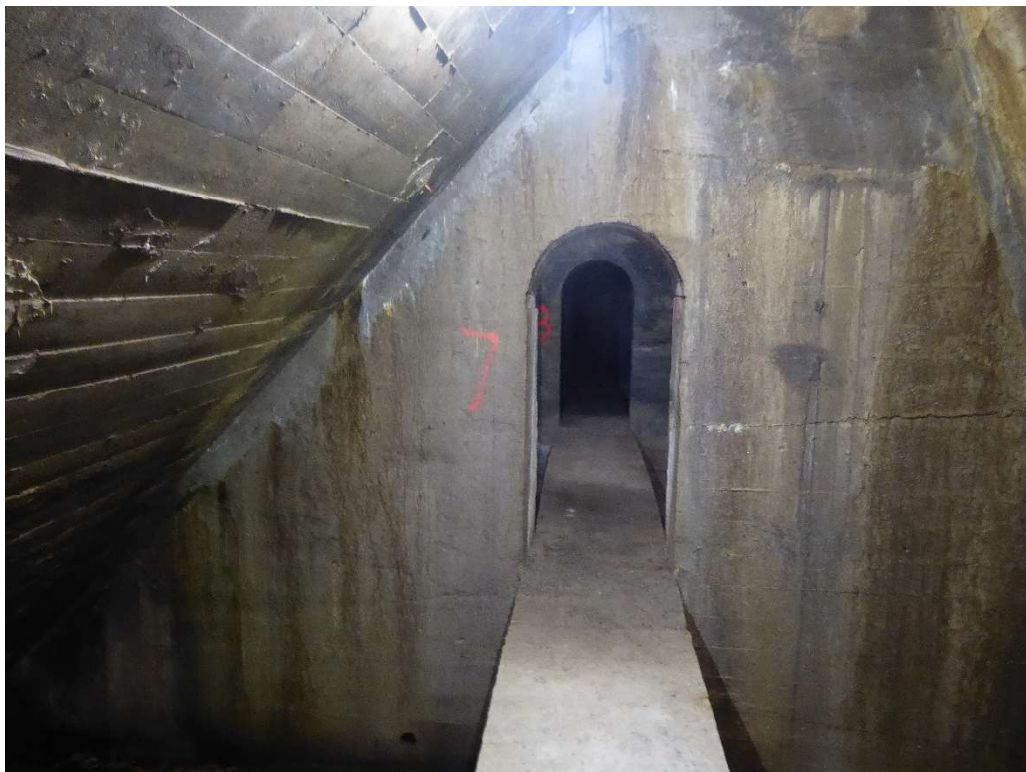
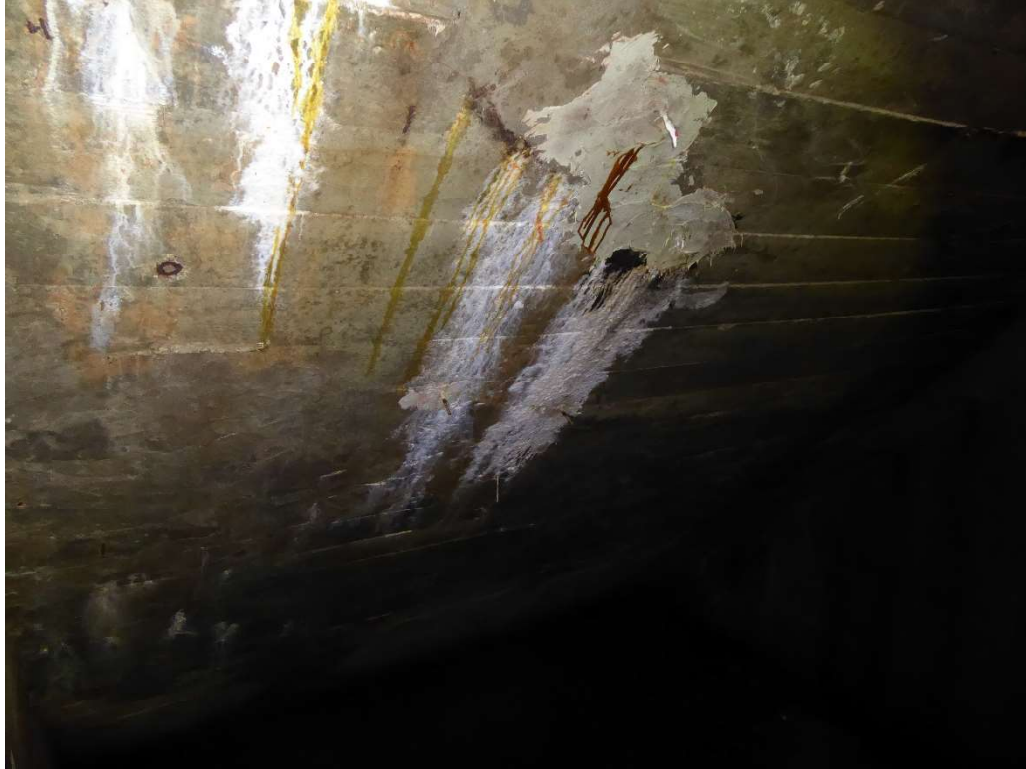
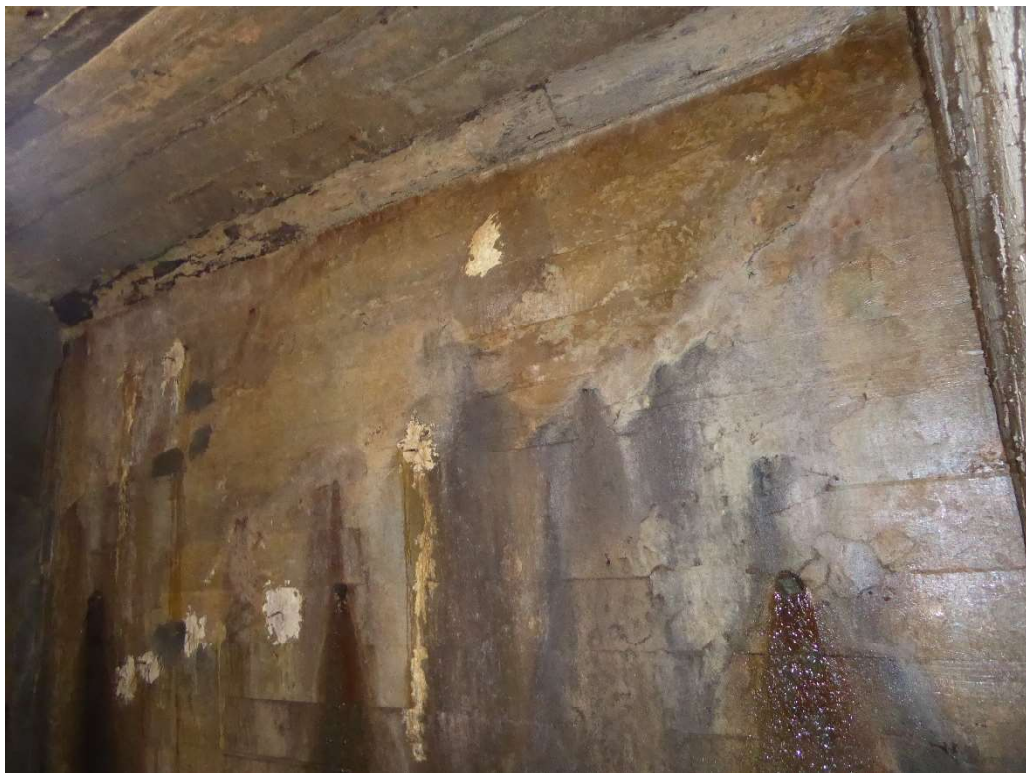
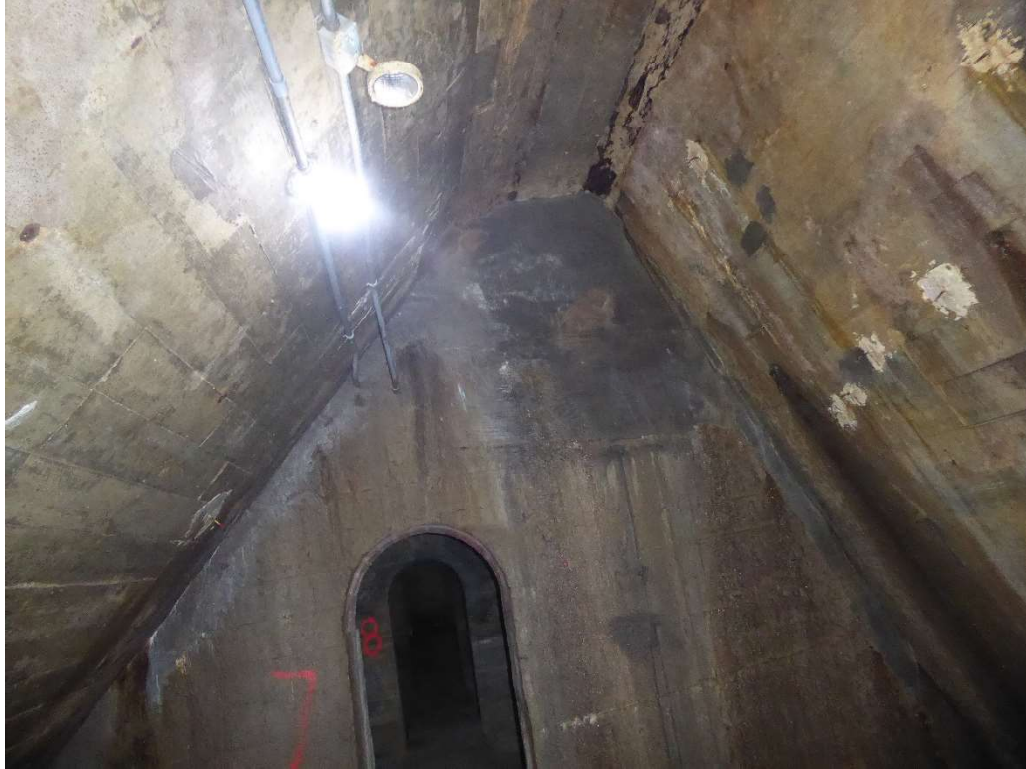
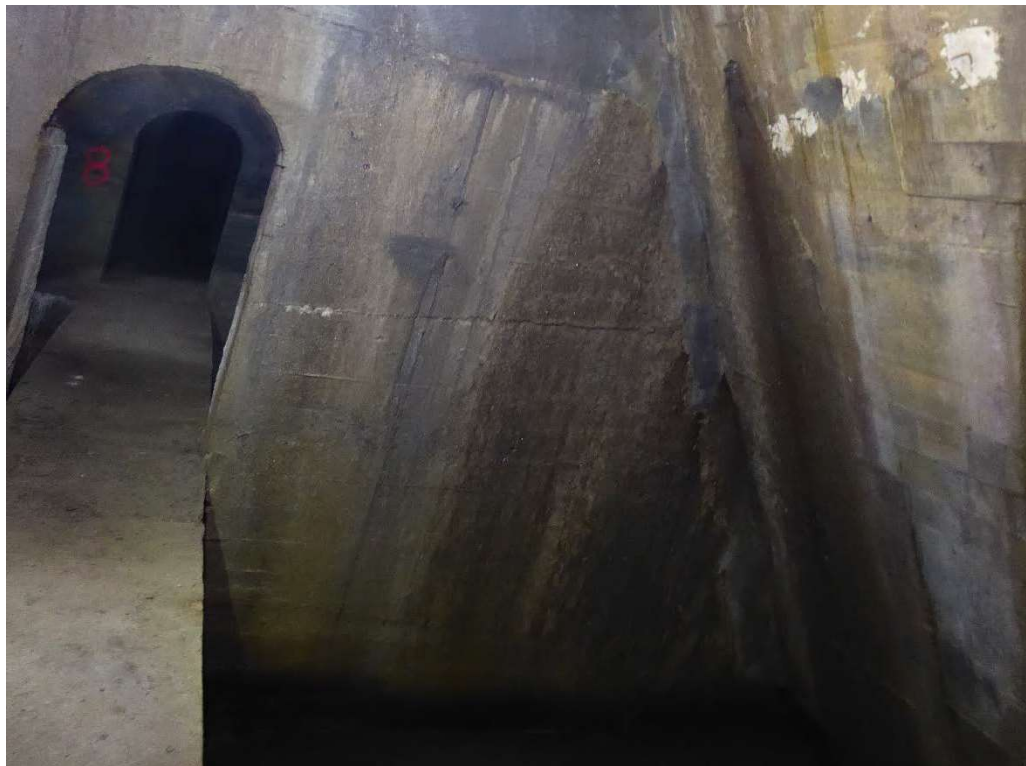
Photo 40: Chamber #7

Photo 41: Upstream Face - Chamber #7

Photo 42: Downstream Face - Chamber #7

Photo 43: Chamber #7

Photo 44: Chamber #7
