Dam Inspection Report

Name of Dam Wonder Lake Dam ID No. IL00585
 Permit Number NE2003078 Class of Dam Class I
 Location SE Section 6 Township 45N Range 8E
 Owner Master Property Owners Assoc. of Wonder Lake 815-653-1000
 Name Telephone Number (Day)
7602 Hancock Drive 815-653-1000
 Street Telephone Number (Night)
Wonder Lake, IL 60097 McHenry
 City Zip Code County

Type of Dam: Earth-Fill Embankment with Ambursen Spillway
 Type of Spillway: Ungated Overflow
 Date(s) Inspected 10/17/2023
 Weather When Inspected Partly Cloudy
 Temperature When Inspected 60 degrees
 Pool Elevation When Inspected 802.47 (approximately 2" above spillway crest (EL. 802.3'))
 Tailwater When Inspected NA

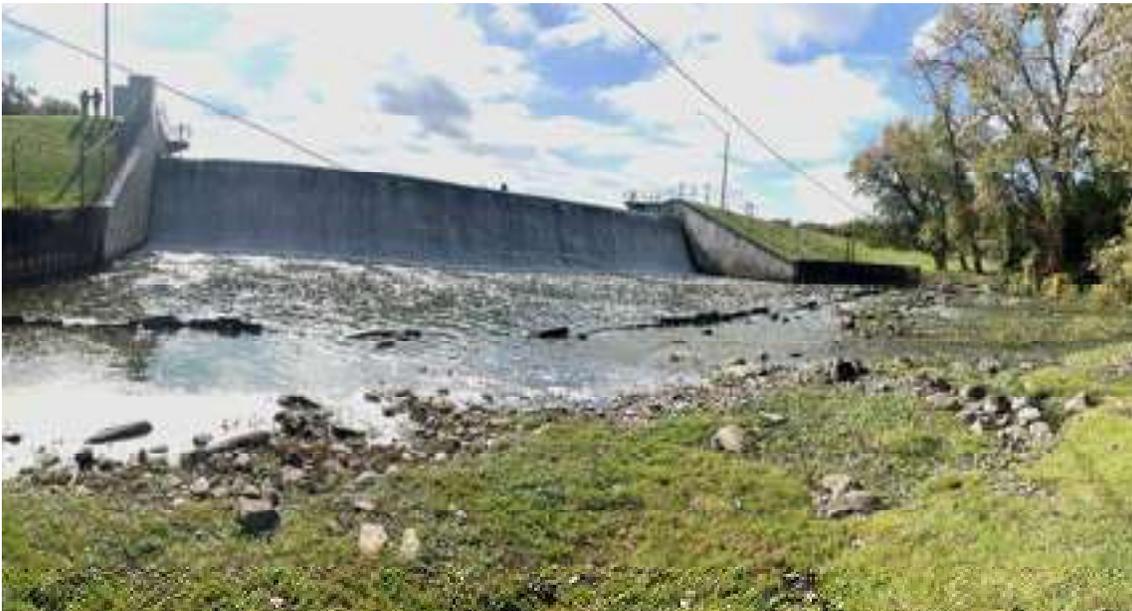
ITEM	CONDITION CODE	DEFICIENCIES	RECOMMENDED REMEDIAL MEASURES AND IMPLEMENTATION SCHEDULE
Erosion, Spalling, Cavitation	<i>MM</i>	Minor spalling is evident.	Perform concrete repairs as needed.
Structure to Embankment Junction	<i>OB</i>	Work on retaining walls has been completed in 2022.	Monitor additional areas of spalling concrete and repair as needed.
Drains	<i>NE</i>		
Seepage Around or Into Structure	<i>MM</i>	Minor seepage and weeping thru several walls. There were seepage through top of spillway at chamber 3 and 7. The seepage is similar to last year's inspection.	Continue to monitor.
Surface Cracks	<i>OB</i>	Existing grouted repair areas appear in good condition. There are minor cracks with leaching that should be monitored for future leaking.	Continue to monitor for any changes to current conditions.
Structural Cracks	<i>MM</i>	There are some minor cracks at within most chambers.	Continue to monitor for any changes to current conditions. Area around cracks have been repaired.

Photo 2: Downstream Face of Spillway

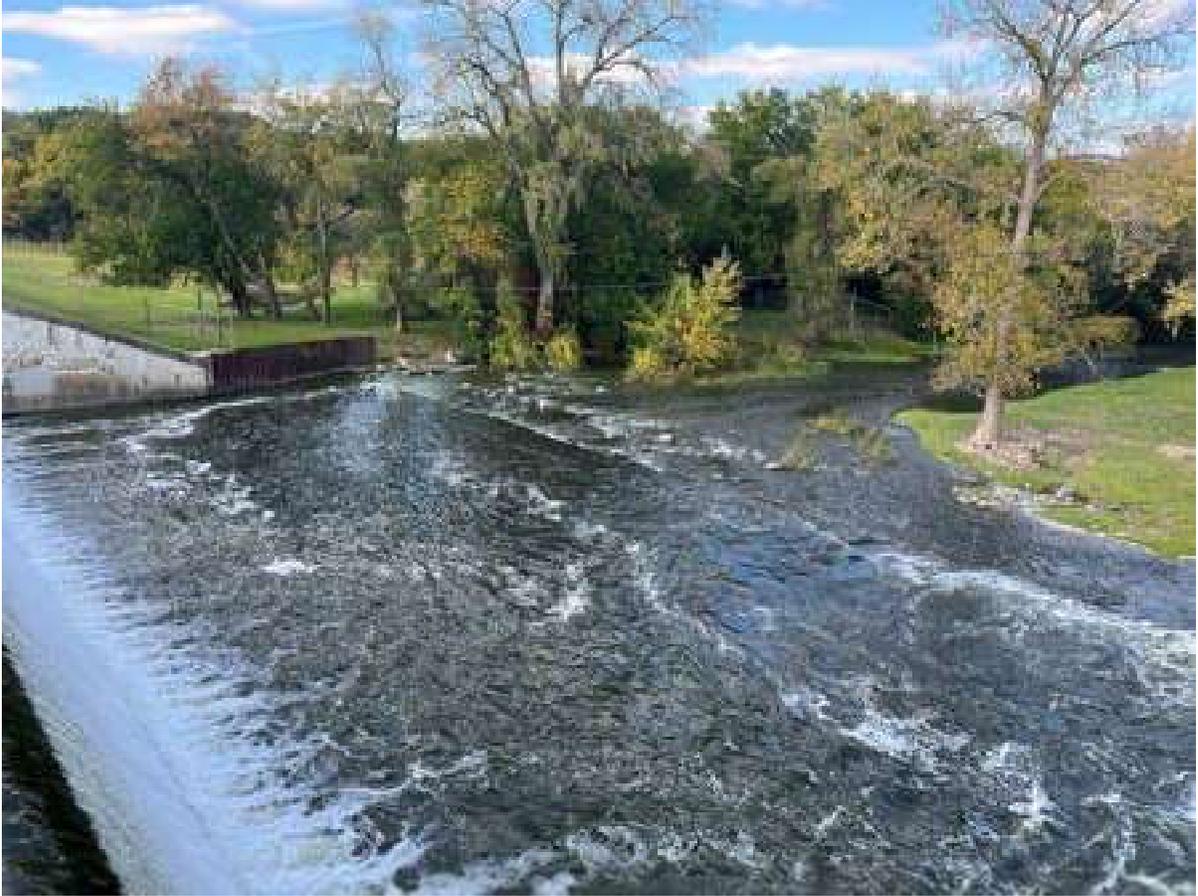
ITEM	CONDITION CODE	DEFICIENCIES	RECOMMENDED REMEDIAL MEASURES AND IMPLEMENTATION SCHEDULE
Riprap	GC		
Outlet Channel	GC	Minor erosion but overall good condition and stable. No threat to dam.	
Debris	NE		
Other (Name)	NA		
Other	NA		
Other			
Other

Photo 3: Downstream Channel

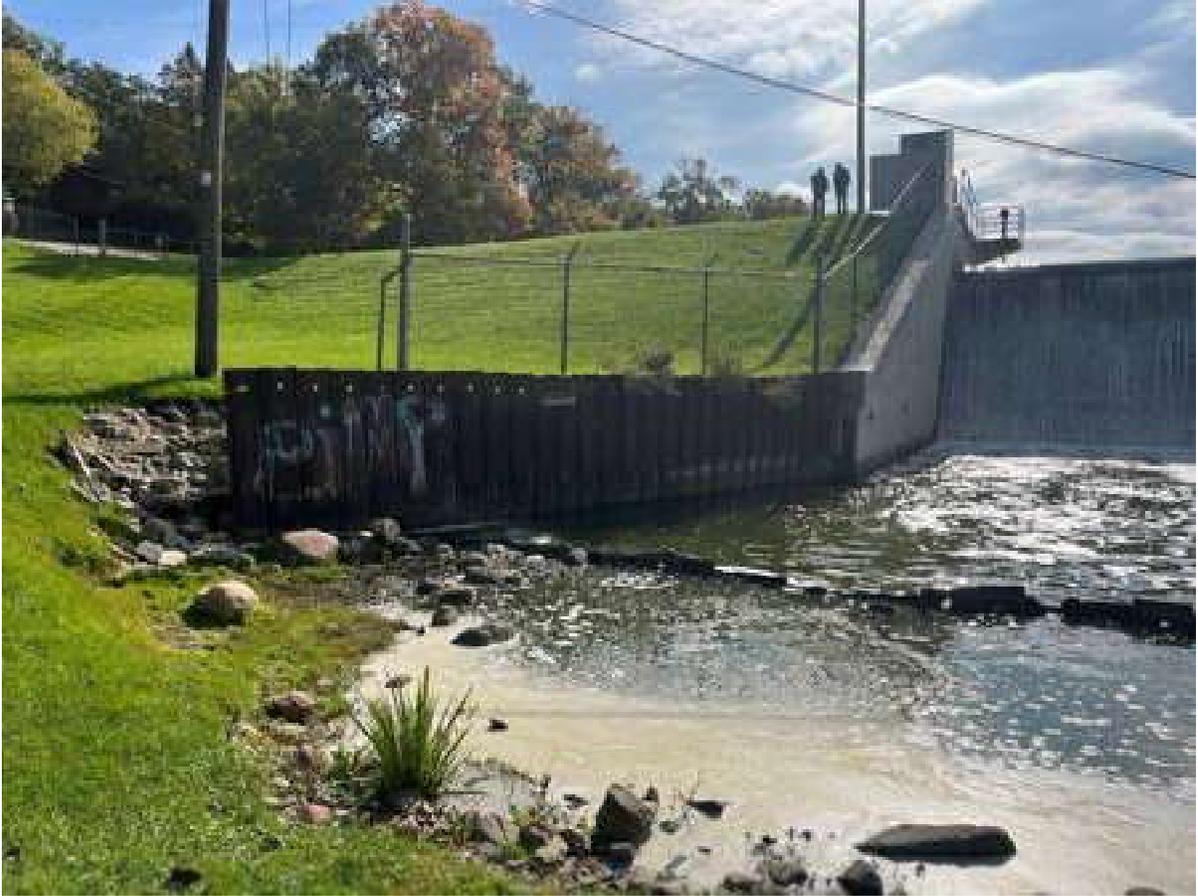
*The eastern abutment concrete cap
was replaced.*

Photo 4 - Downstream Face of Spillway (East Abutment)

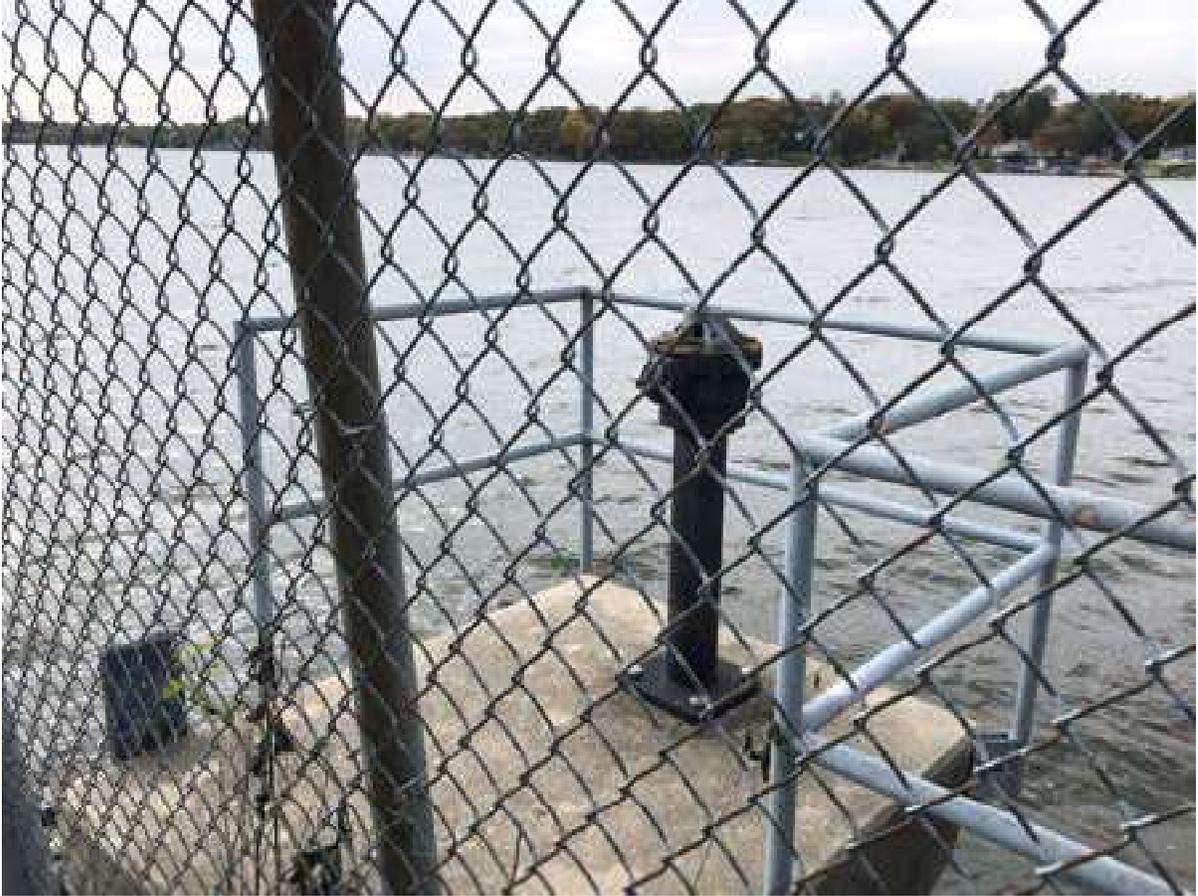
*Exercising East dewatering gate.
West dewatering gate inoperable.*

Photo 8: East Sluice Gate Control

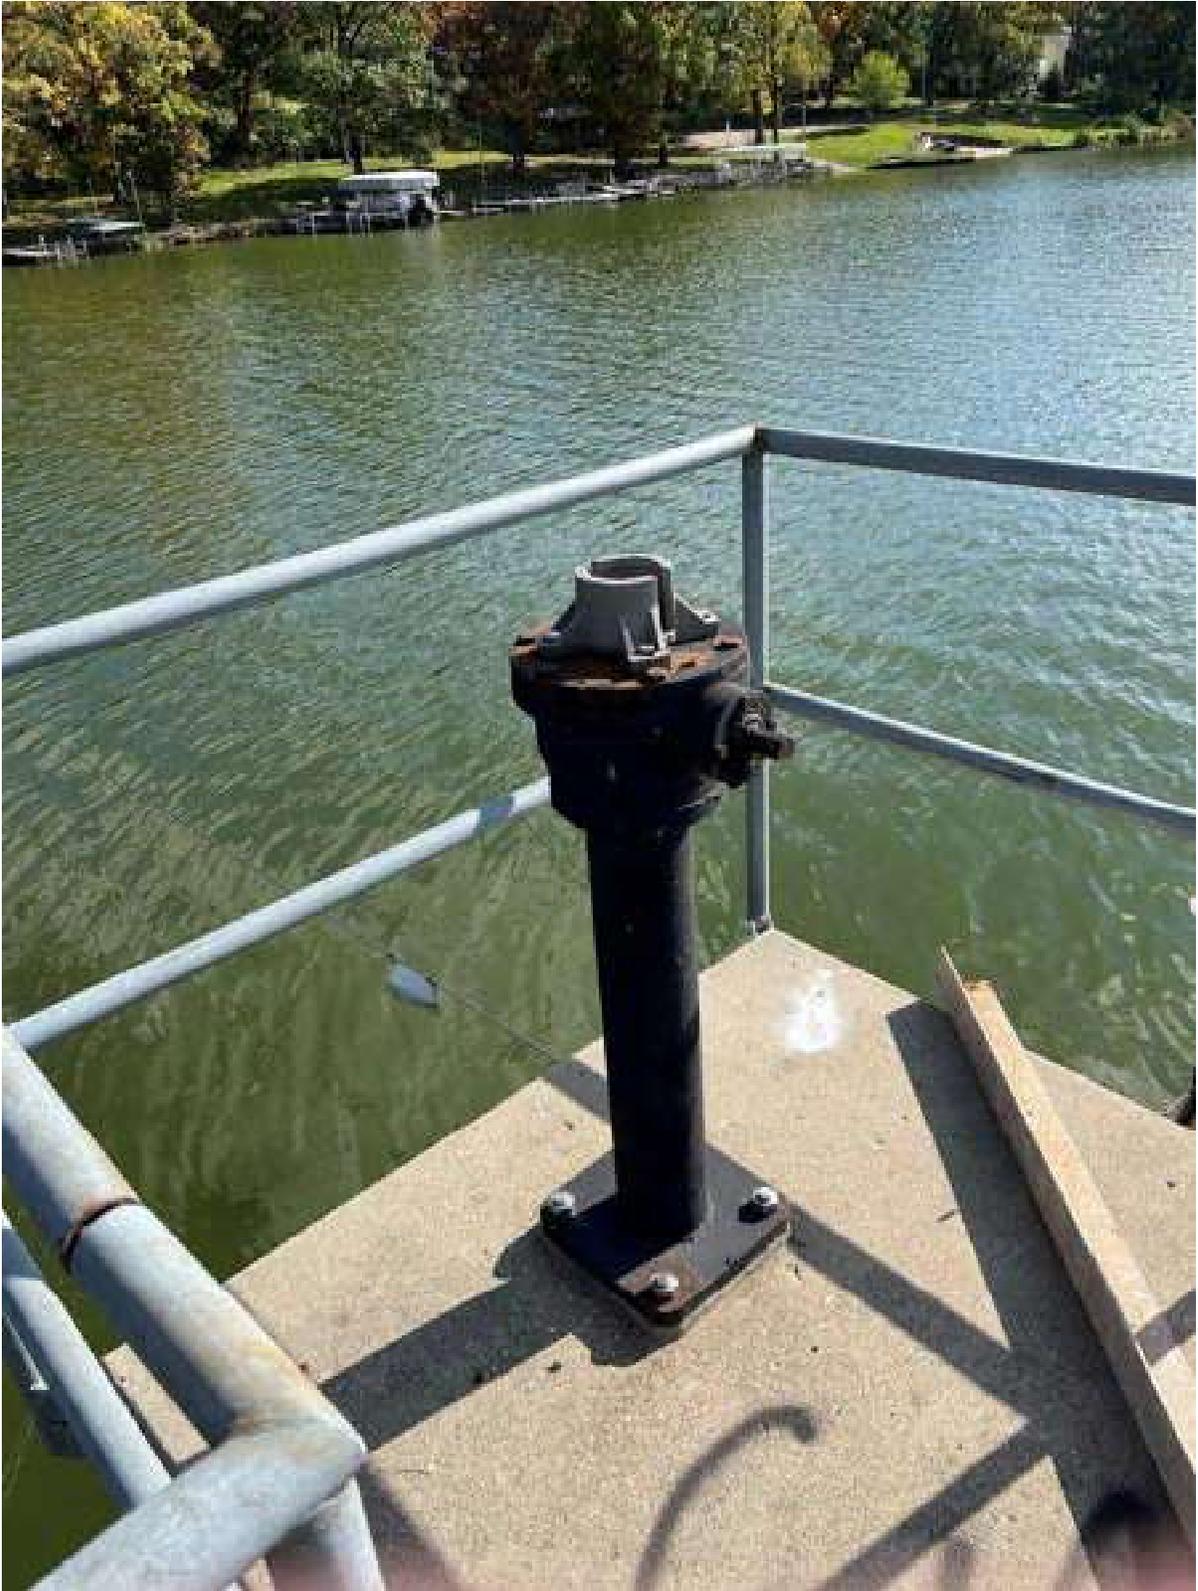
Photo 9: West Sluice Gate Control

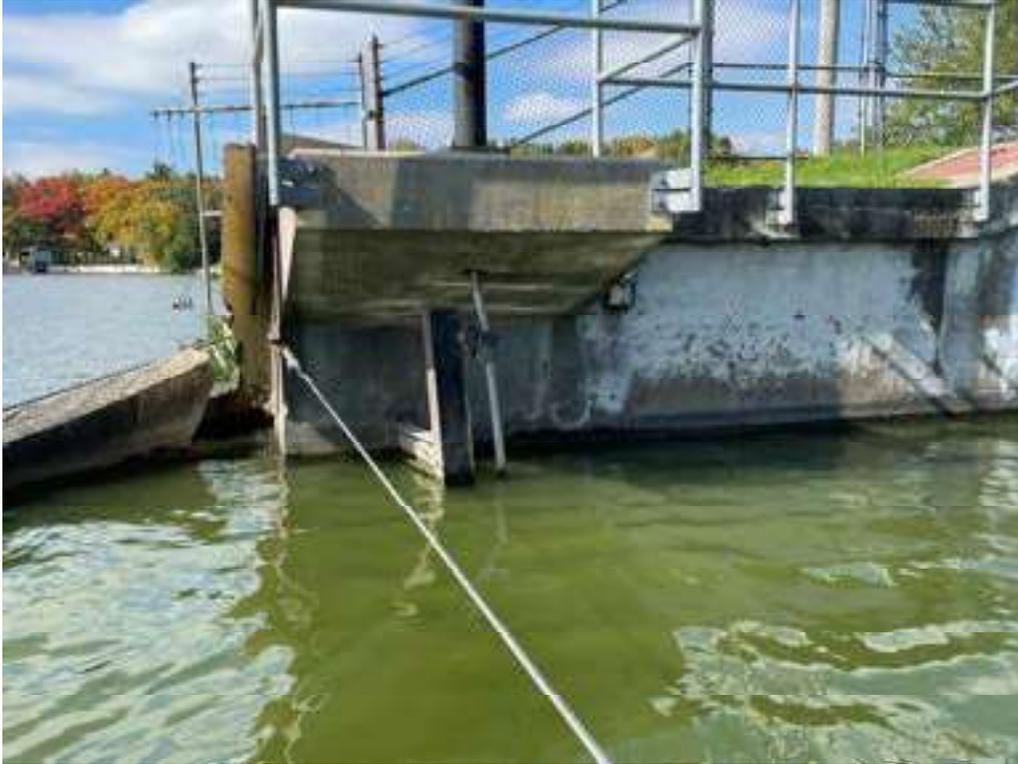
ITEM	CONDITION CODE	DEFICIENCIES	RECOMMENDED REMEDIAL MEASURES AND IMPLEMENTATION SCHEDULE
Gate Sill	<i>GC/MM</i>	East Gate was opened and closed during the dam inspection. There are no issues with the gate components. West Gate inoperable.	Repair West Gate.
Gate Seals	<i>GC/MM</i>	East Gate was opened and closed during the dam inspection. There are no issues with the gate components. West Gate inoperable.	Repair West Gate.
Gate and Frame	<i>GC/MM</i>	East Gate was opened and closed during the dam inspection. There are no issues with the gate components. West Gate inoperable.	Repair West Gate. Note that west gate shaft and steel protection framing are bent.
Operating Machinery	<i>NI</i>		
Emergency Operating Machinery	<i>NA</i>		
Other (Name)			
Other

Photo 10a: West Sluice Gate – Shaft and steel protection framing is bent – Gate is inoperable

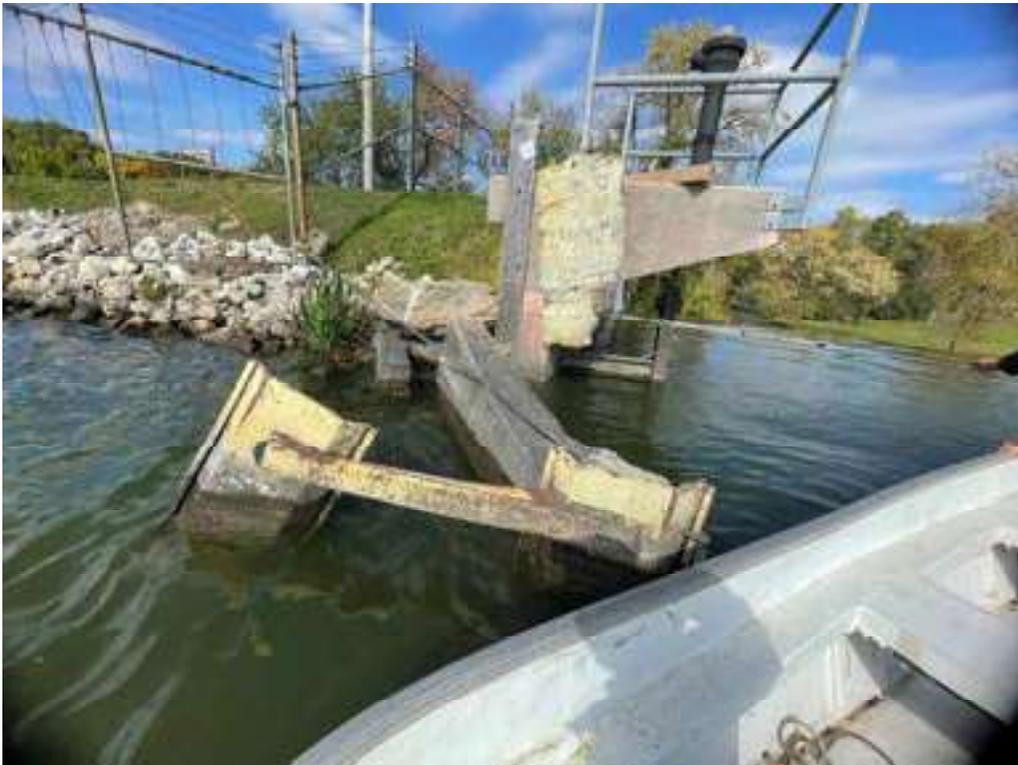
Photo 10b: Upstream of West Sluice Gate

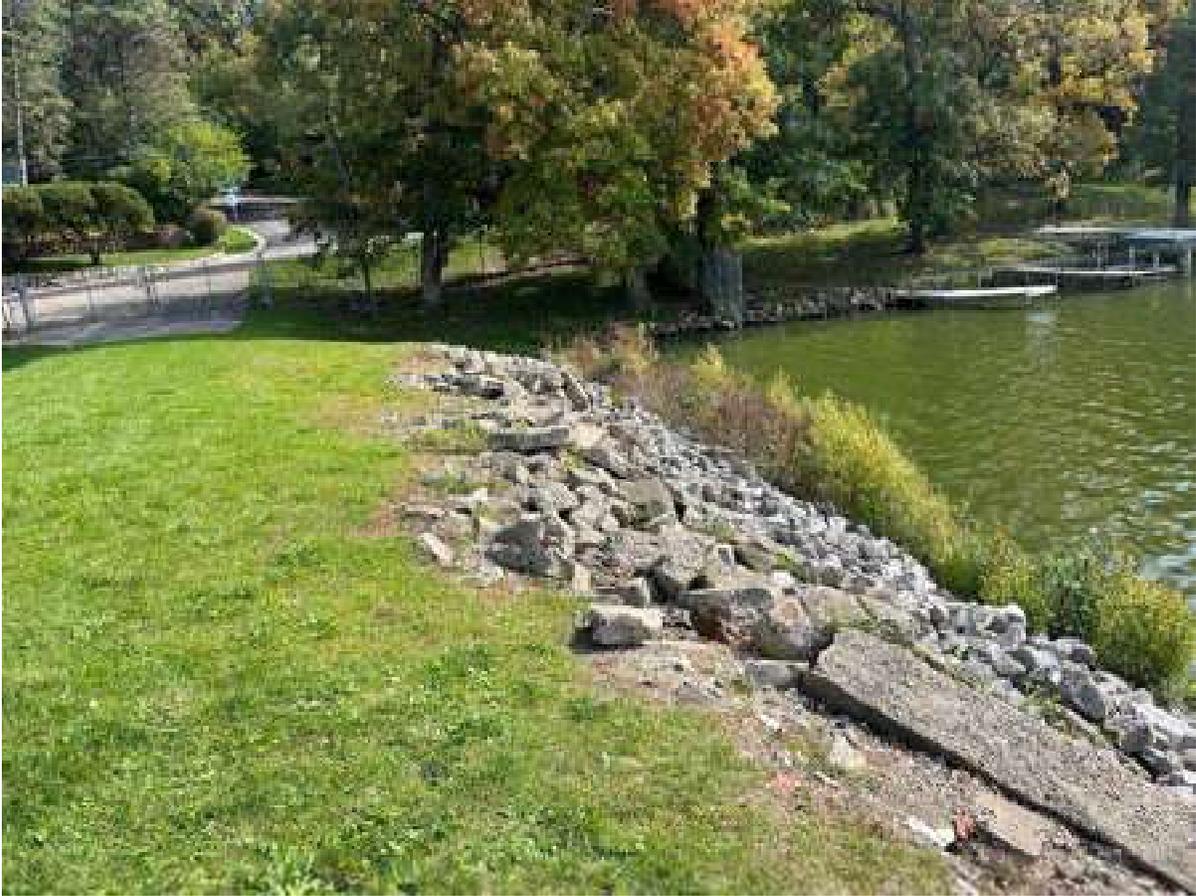
ITEM	CONDITION CODE	DEFICIENCIES	RECOMMENDED REMEDIAL MEASURES AND IMPLEMENTATION SCHEDULE
Surface Cracks	NE		
Vertical and Horizontal Alignment of Crest	GC		
Unusual Movement or Cracking At or Beyond Toe	NE		
Sloughing or Erosion of Embankment and Abutment Slopes	NE		
Upstream Face Slope Protection	GC		RipRap is in good shape
Seepage	OB	<i>There is some standing water at toe of west embankment due to adjacent Fen located to the north</i>	<i>Monitor for any changes This wet area has remained unchanged from the October 13, 2016 Dam Inspection</i>
Filter and Filter Drains	NE

Photo 12: East Embankment – Upstream Face Riprap (Facing East)

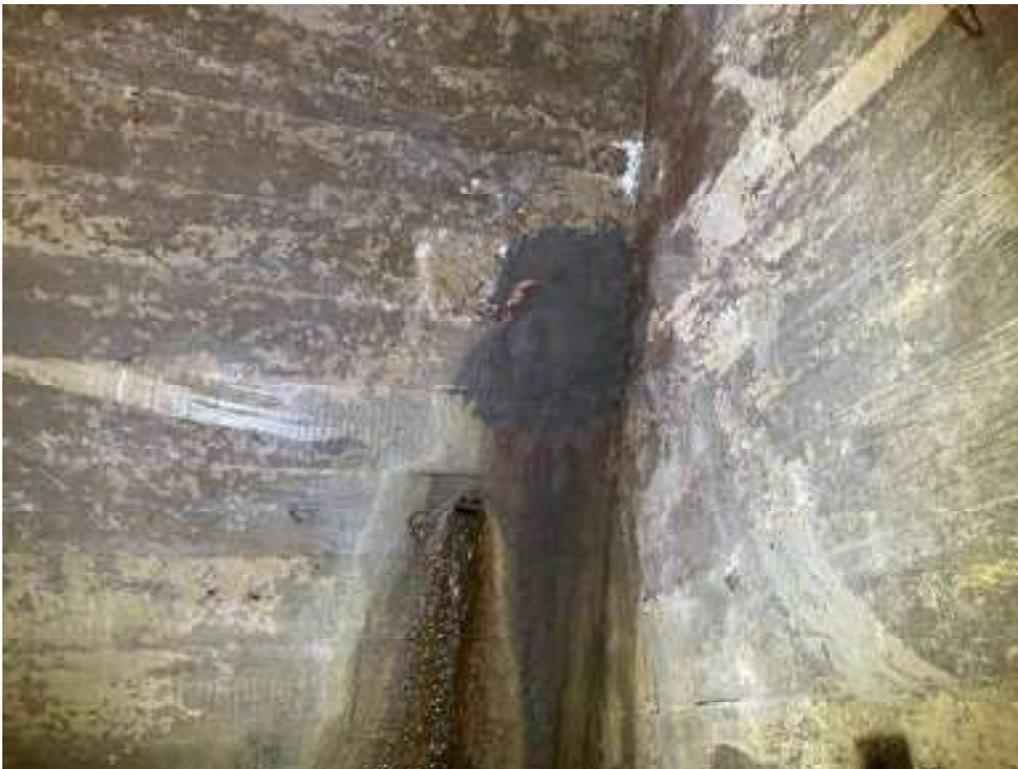
Photo 23-Downstream Wall, East End Patch – Chamber #3

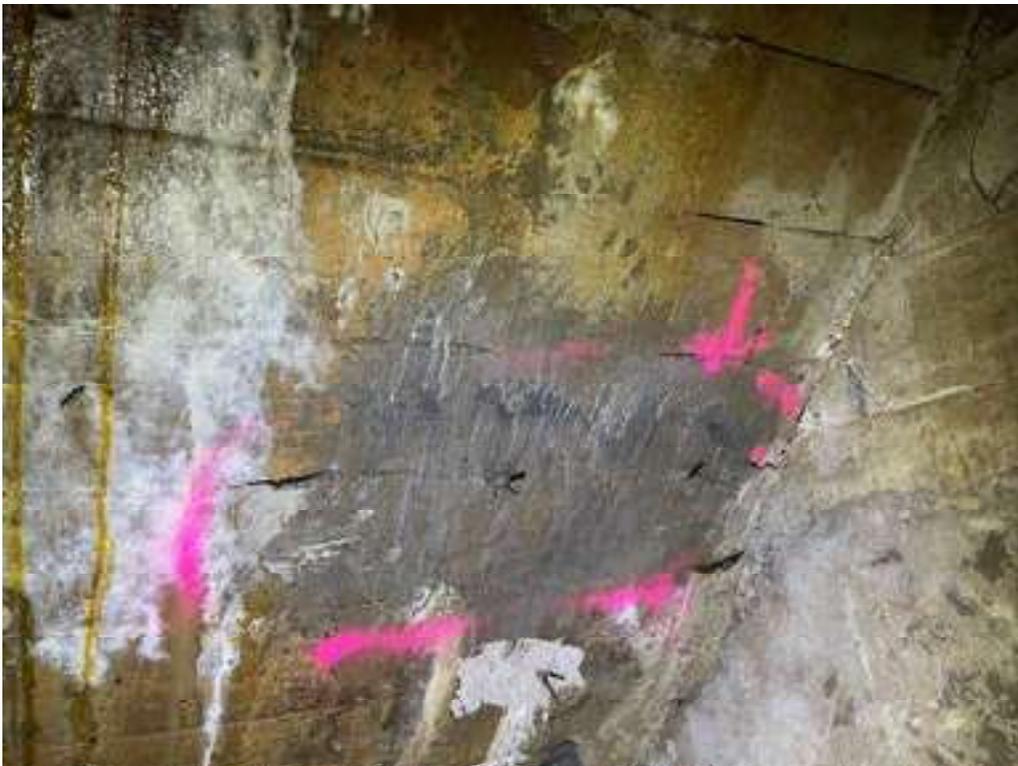
Photo 33: Patch in Upstream Face – Chamber #6
