Dam Inspection Report

Name of Dam Wonder Lake Dam ID No. IL00585

Type of Dam: Earth-Fill Embankment with Ambursen Spillway

Date(s) Inspected _ 10/3/2025

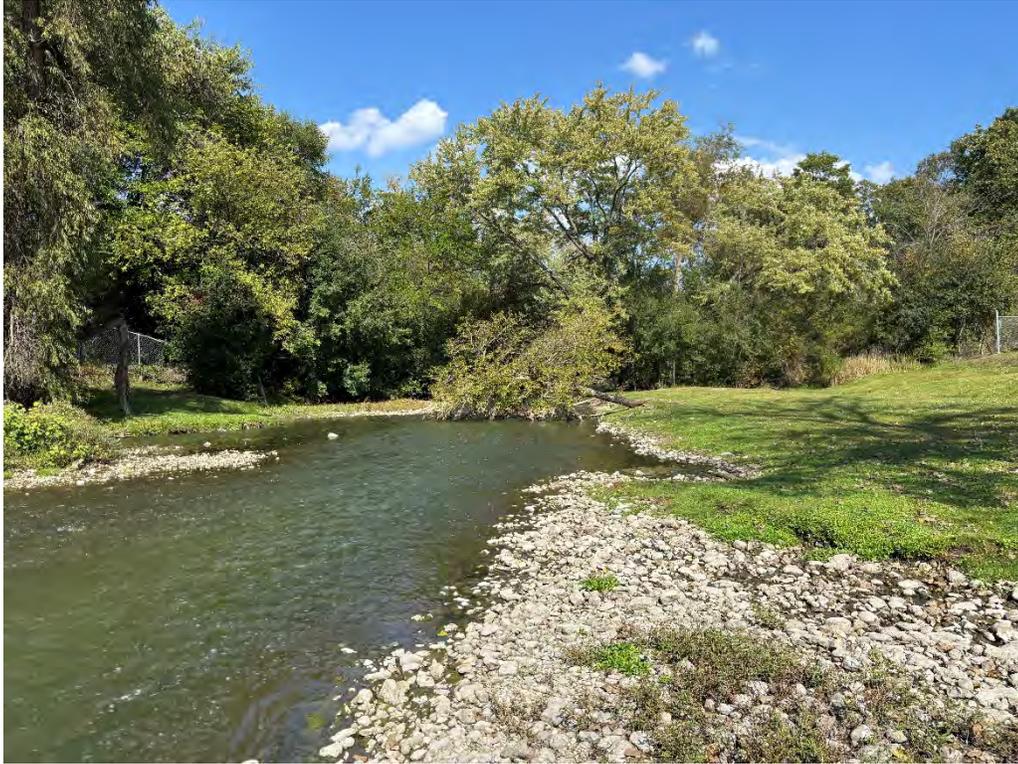
ITEM	CONDITION CODE	DEFICIENCIES	RECOMMENDED REMEDIAL MEASURES AND IMPLEMENTATION SCHEDULE
Riprap	GC		
Outlet Channel	GC	Minor erosion but overall good condition and stable. No threat to dam.	
Debris	NE		
Other (Name)	NA		
Other	NA		
Other			
Other

Photo 3: Downstream Channel

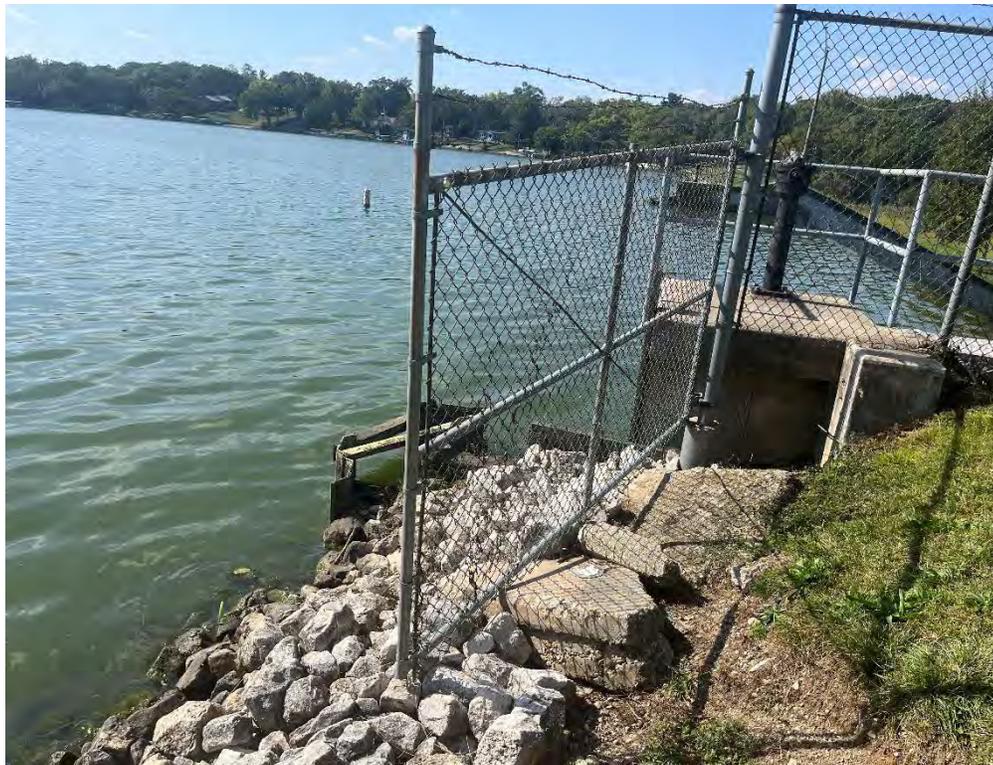
Photo 8: East Sluice Gate Control

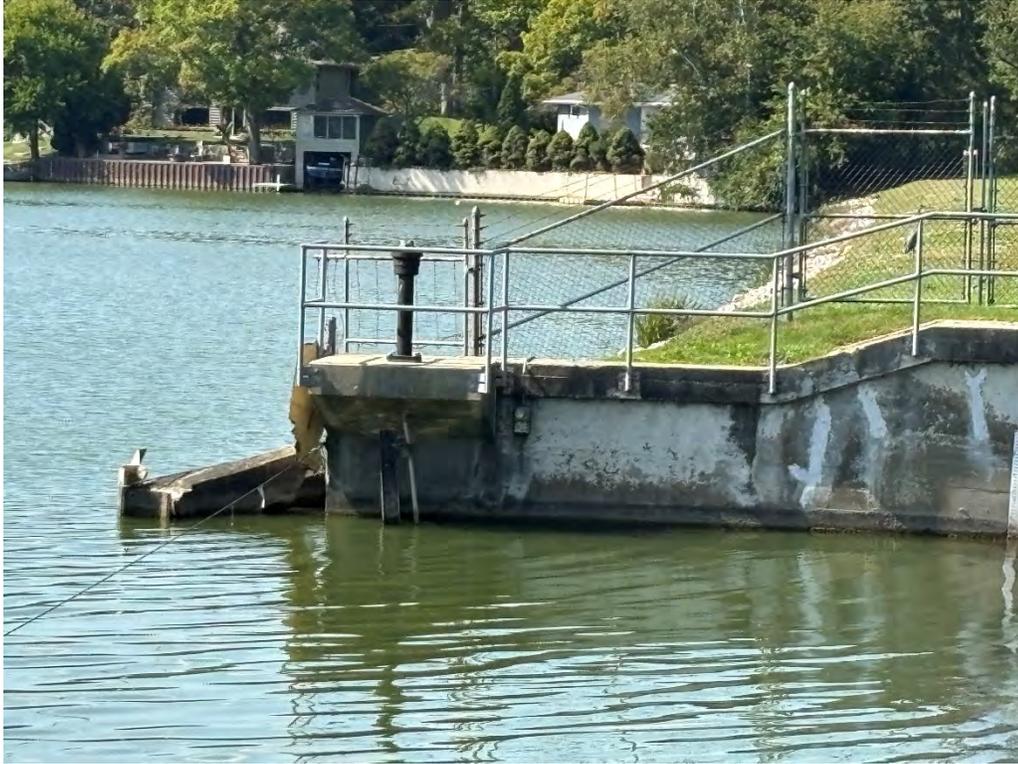
ITEM	CONDITION CODE	DEFICIENCIES	RECOMMENDED REMEDIAL MEASURES AND IMPLEMENTATION SCHEDULE
Gate Sill	<i>GC/MM</i>	East Gate was opened and closed during the dam inspection. There are no issues with the gate components. West Gate inoperable.	Repair West Gate. Discussions with contractors are underway.
Gate Seals	<i>GC/MM</i>	East Gate was opened and closed during the dam inspection. There are no issues with the gate components. West Gate inoperable.	Repair West Gate. Discussions with contractors are underway.
Gate and Frame	<i>GC/MM</i>	East Gate was opened and closed during the dam inspection. There are no issues with the gate components. West Gate inoperable.	Repair West Gate. Discussions with contractors are underway. Note that west gate shaft and steel protection framing are bent.
Operating Machinery	<i>NI</i>		
Emergency Operating Machinery	<i>NA</i>		
Other (Name)			
Other

Photo 9: West Sluice Gate – Shaft and steel protection framing is bent – Gate is inoperable – Repairs being discussed with contractors

Exercising East dewatering gate.
West dewatering gate inoperable.
Discussions with contractors underway for
repairs to west gate.

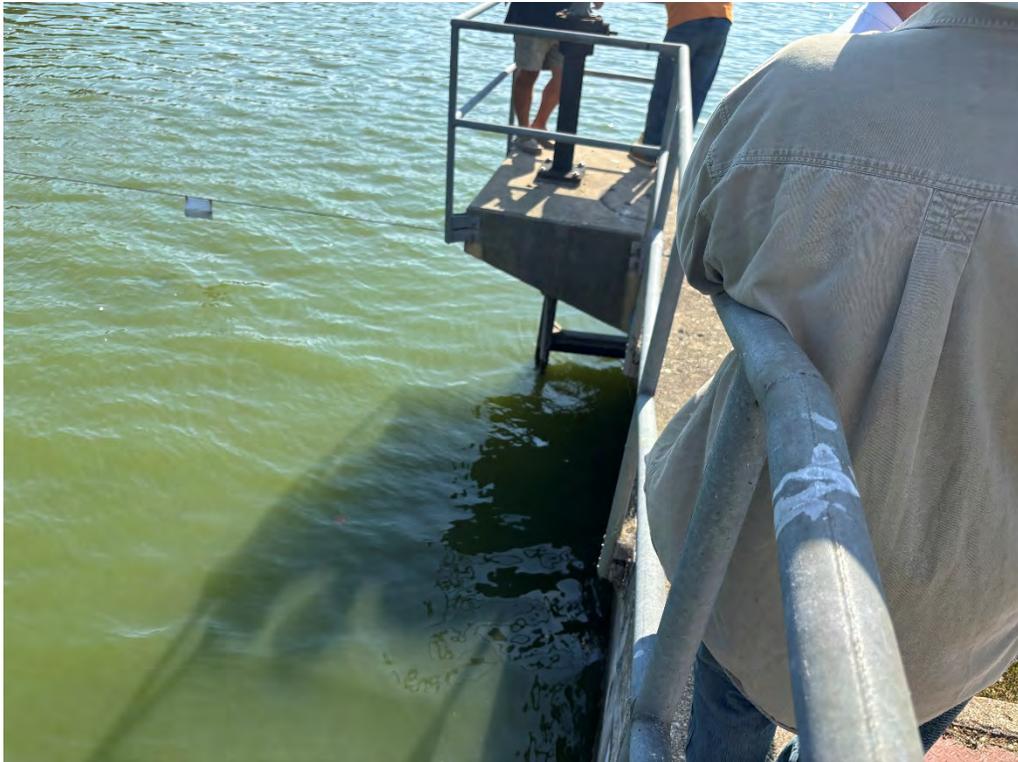
Photo 10: Downstream Side of West Sluice Gate

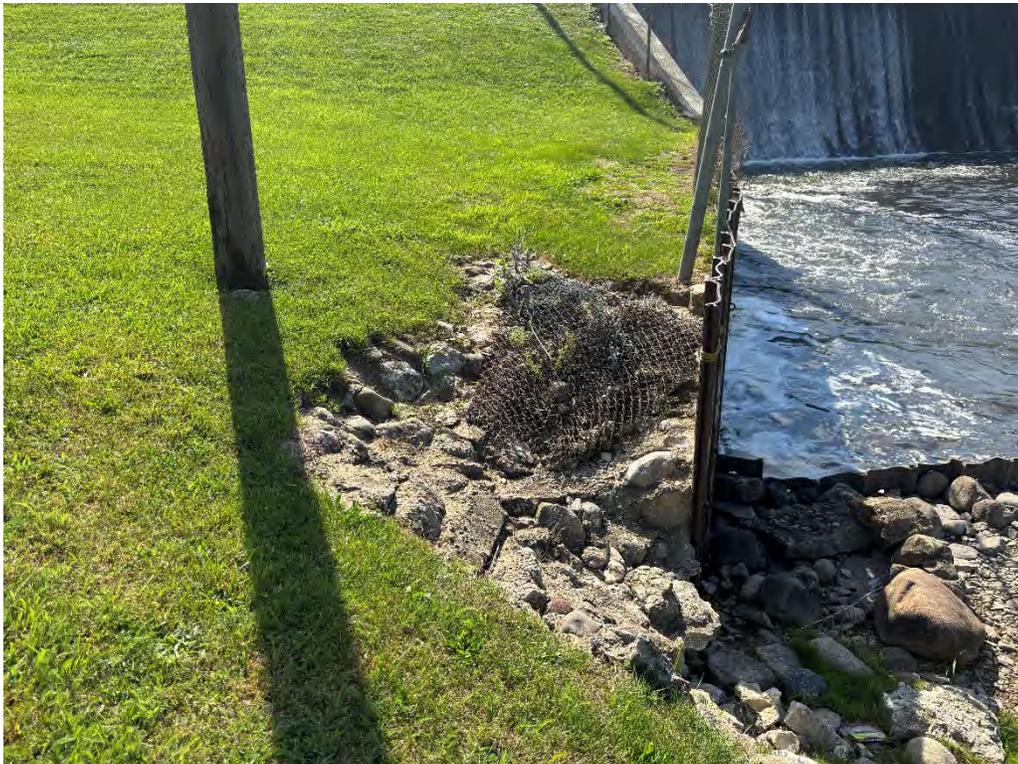
Photo 16 – Erosion at Downstream End of East Abutment - Monitor

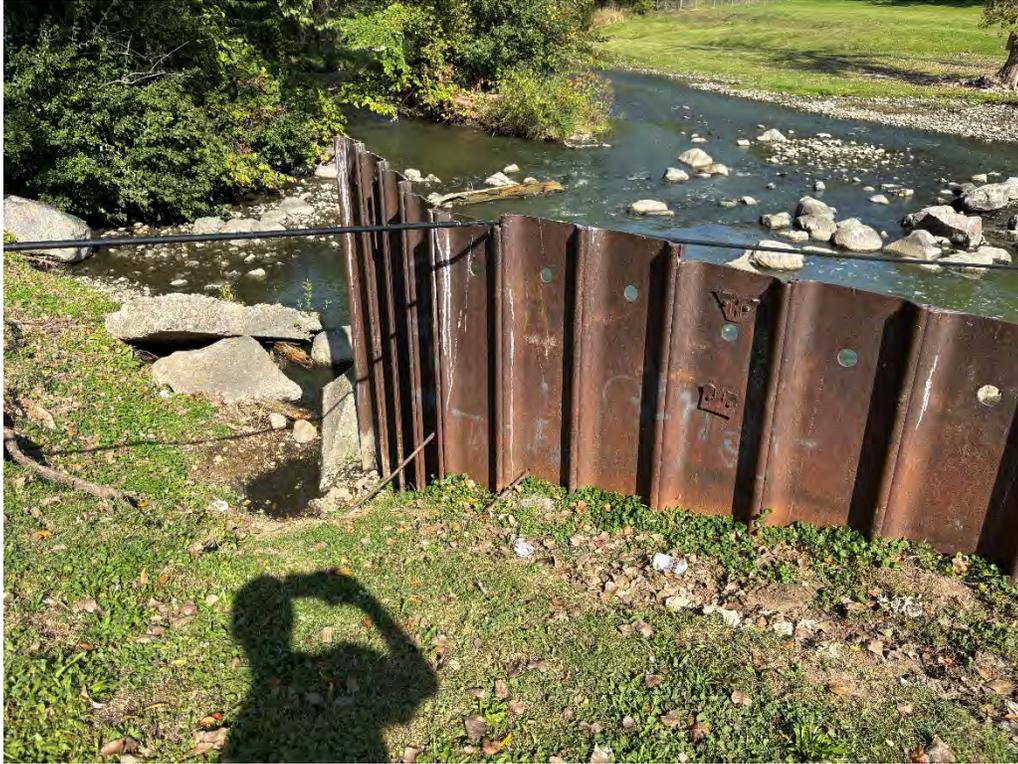
Photo 17 - Erosion at Downstream End of East Abutment - Monitor

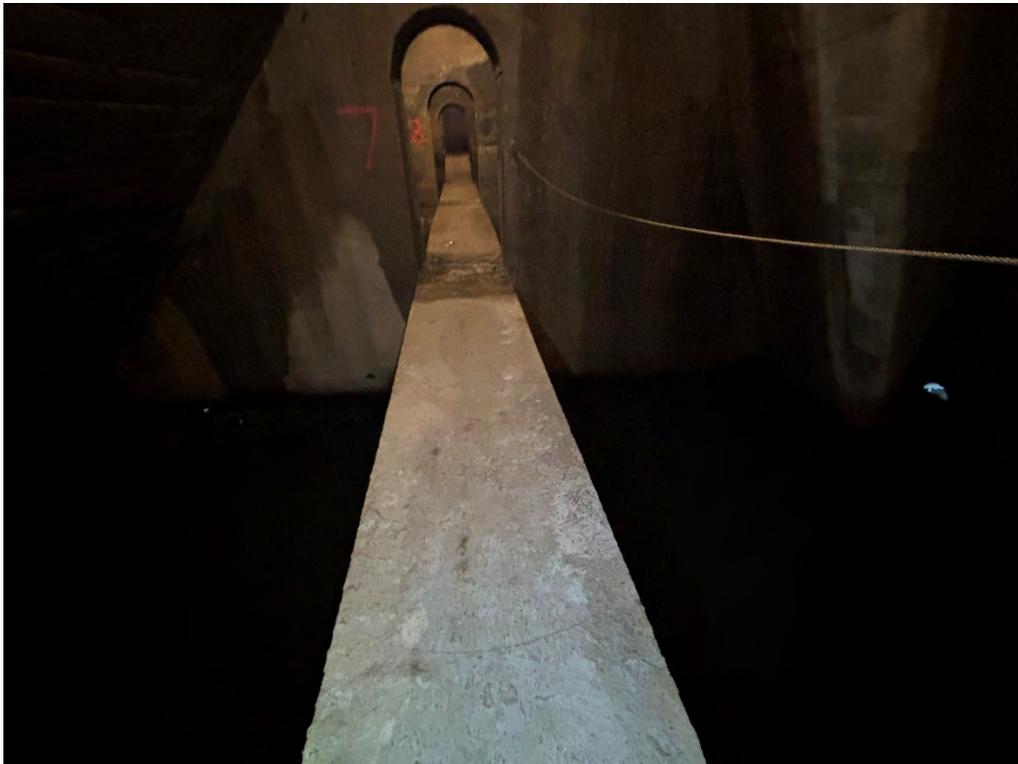
ITEM	CONDITION CODE	DEFICIENCIES	RECOMMENDED REMEDIAL MEASURES AND IMPLEMENTATION SCHEDULE
Alignment of Abutment Walls (wingwalls)	GC		
Construction Joints	NA		
Filter and Filter Drains	NA		
Trash Racks	NA		
Bridge and Piers	NA		
Differential Settlement	NE		
Other (Name)	GC	Safety cables installed along dam walkway.

Photo 58: Typical Walkway Condition
